Infrared Scanning

Infrared Inspections on Electric Panels without Removing Covers: Can the Inspection be Completed Correctly?

*Joe Gierlach, Director, Technical Training and Support, TEGG Corporation
Joe DeMonte Senior Thermography Course Instructor*

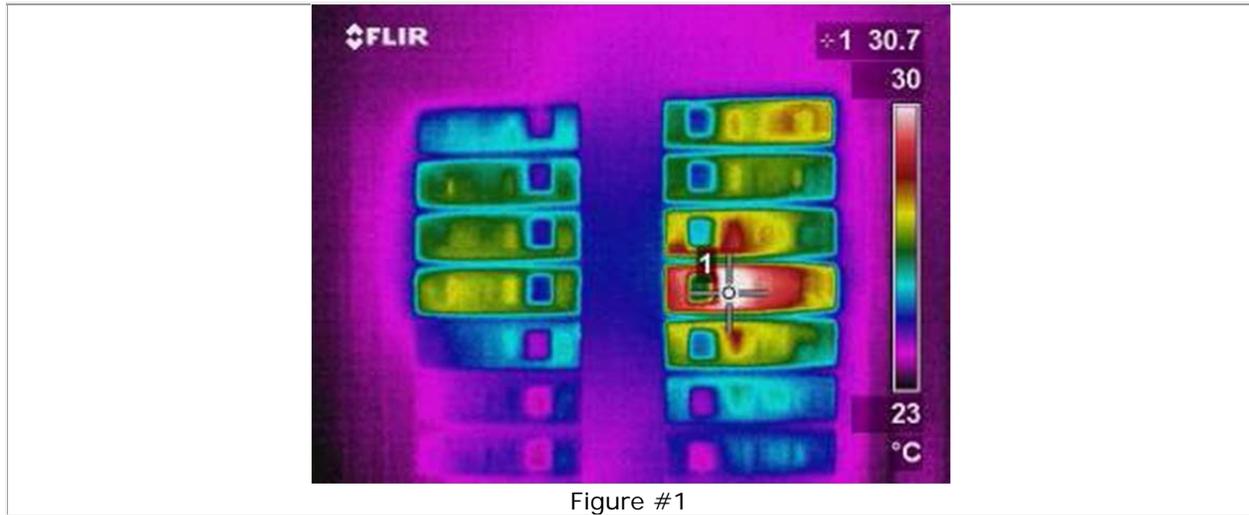
As you can see in Figure #1 prior to the removal of the dead front cover, there is an obvious load on the suspect breaker 4th down on the right.

The observed temperature is around 30 degrees C and within the manufacturer's operating specifications. The temperature on the dead front cover is closer to 23 degrees C and not an apparent concern, right? One may simply deduce this is only load created energy on the breaker and bypass it during an inspection.

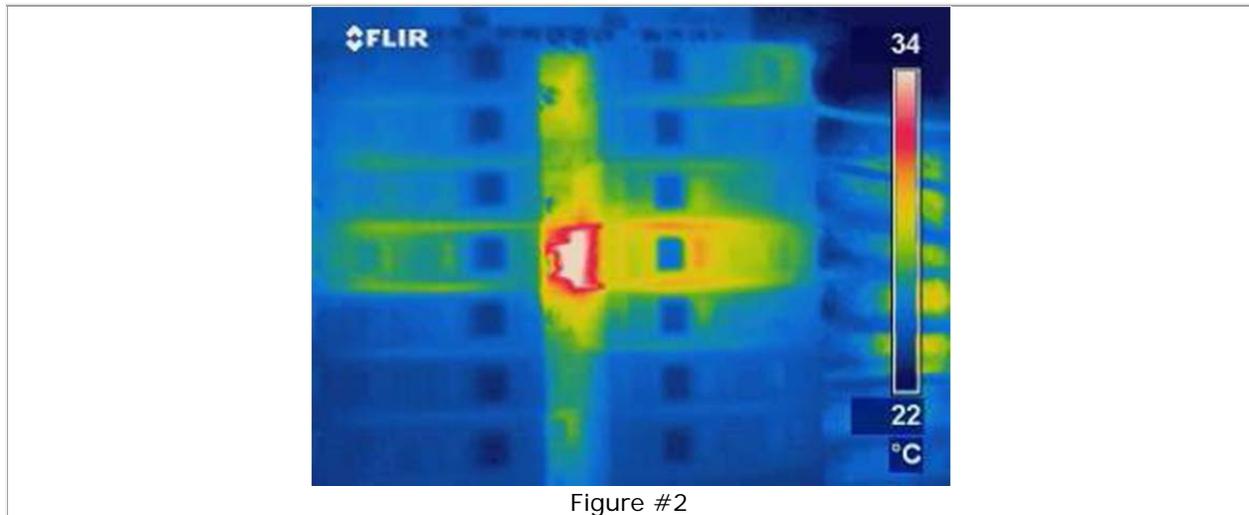
Once the cover is removed, a far worse issue is revealed in Figure #2.

- The problem area is centered on the line side connection.
- The actual problem temperature at this light load was approximately 39 degrees C.
- This is an error of nearly 9 degrees C.
- If the cover had not been removed, this more than likely would have been bypassed.
- Any addition of loads would increase the problem temperature exponentially.

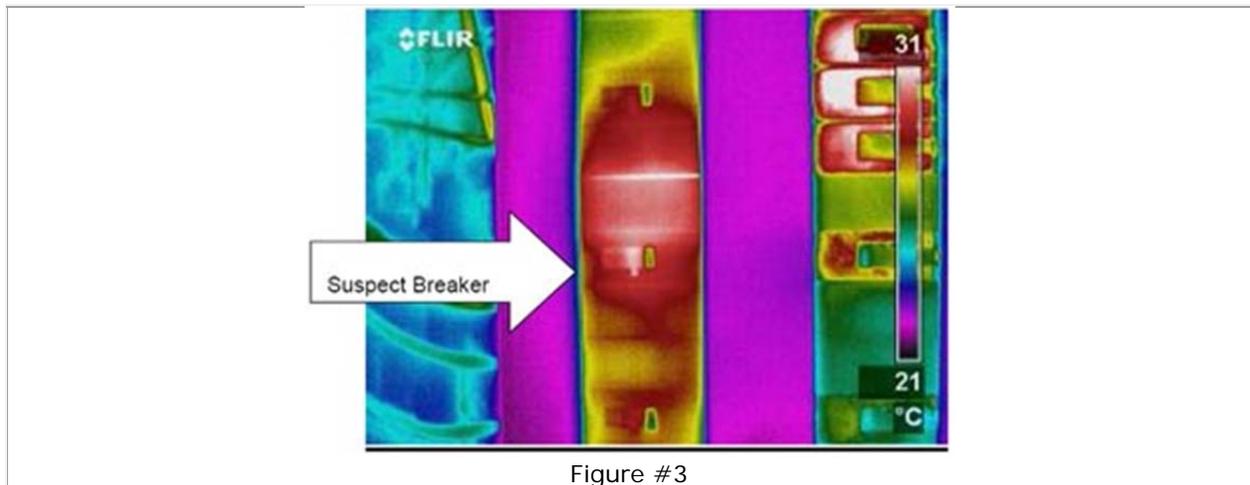
- Again, a lightly loaded breaker compared to the rating.
- Around 32 degrees C on the breaker case and well within the manufacturer's specifications for rise over ambient.
- No apparent "deficiency" was observed relating to temperature on the dead front cover, and it was operating at around 22 degrees C, which can be seen by viewing the thermal image in Figure #3.
- But when the cover is removed, a different story is uncovered, as is shown in Figure #4.
- As seen below in Figure #4, the actual problem area again is the bus connection to the breaker.
- But unlike the 22 degrees C observed on the dead front cover, the problem temperature is now running closer to 43 degrees C.
- This is an error of nearly 22 degrees C.

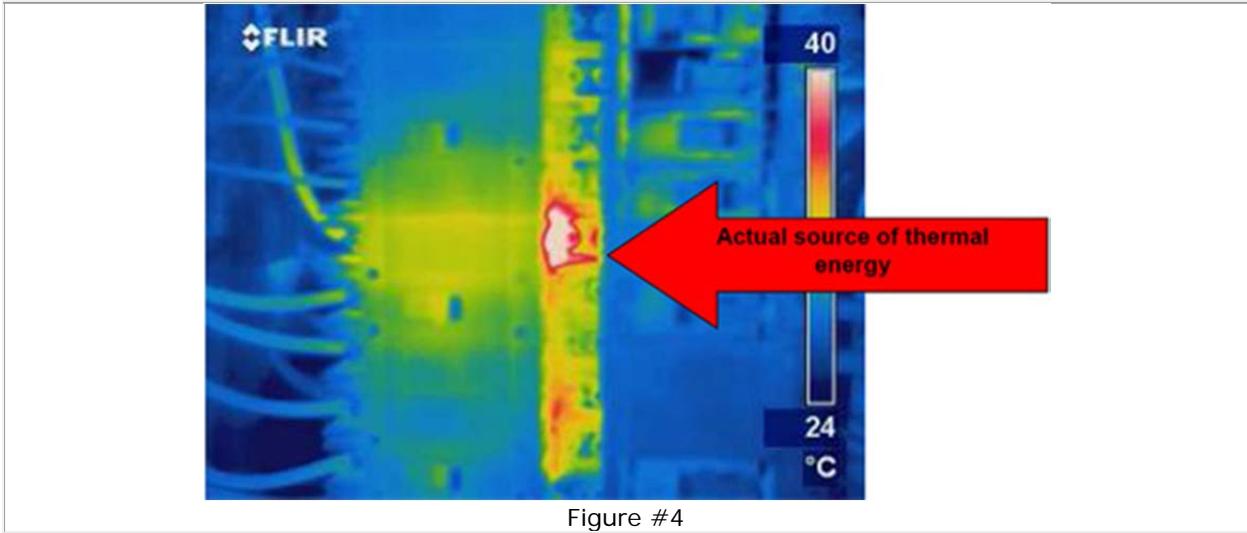
Again, with load demand being light at the time of the survey, increases and the consequences thereof must be considered. This is another clear example of how temperature errors by improper procedure of the technology for the electrical application can occur.

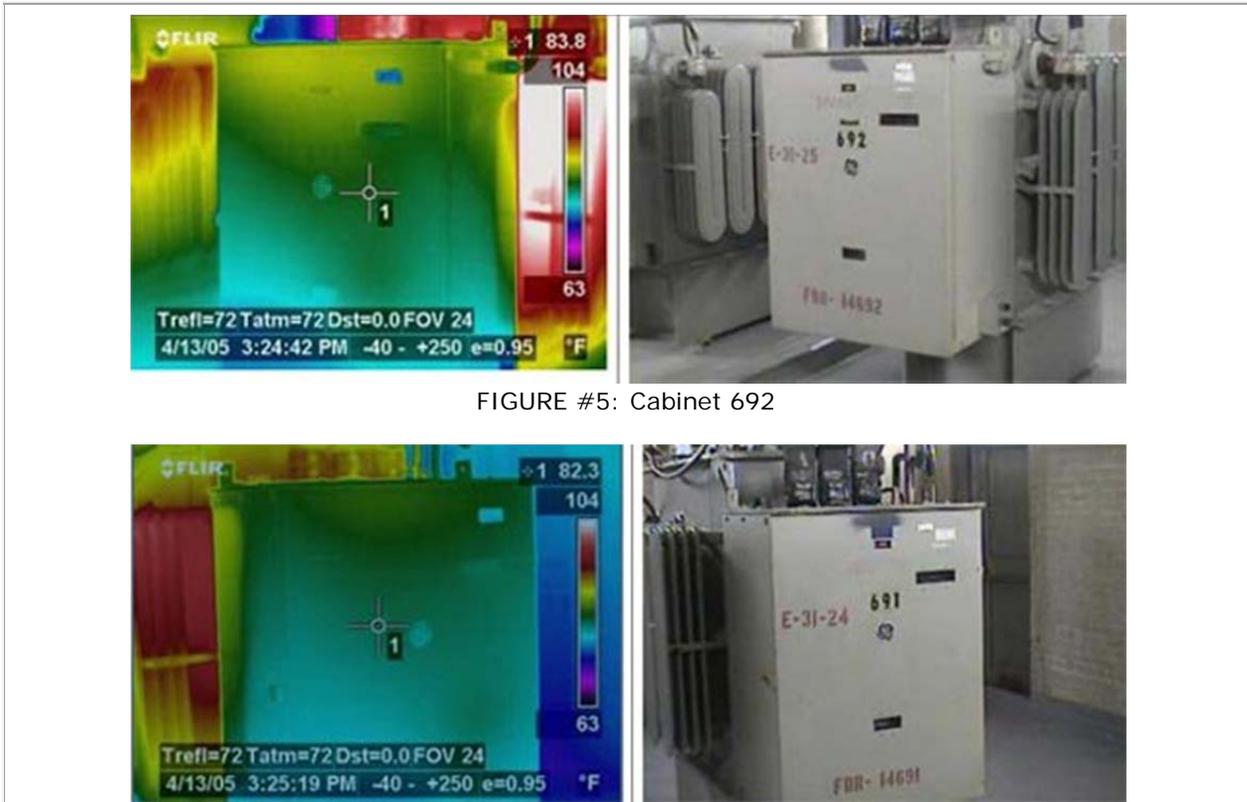
Consider the infrared and visual images shown in Figures #5 and #6. Both show the 480V buss cabinet and connections associated with a 13.2KV to 480V step down transformer. The cabinet in Figure #5 is running approximately 2°F warmer and shows considerable heat towards the top of the cabinet due to convective gains. This would seem to point to a potential issue in the 692 cabinet and no issue in the 691 cabinet. However, upon removal of each of the covers by approved safety measures, we scan with the IR camera again and find the images to be opposite of what we originally thought.

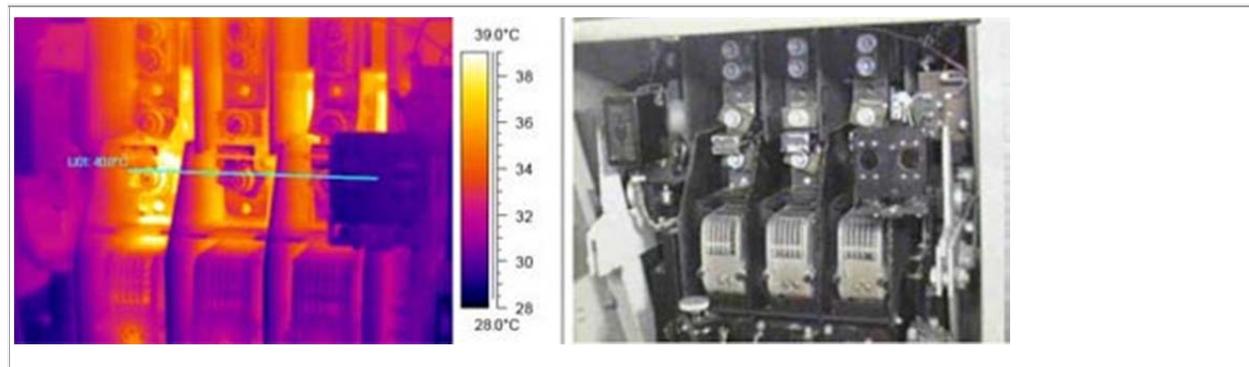
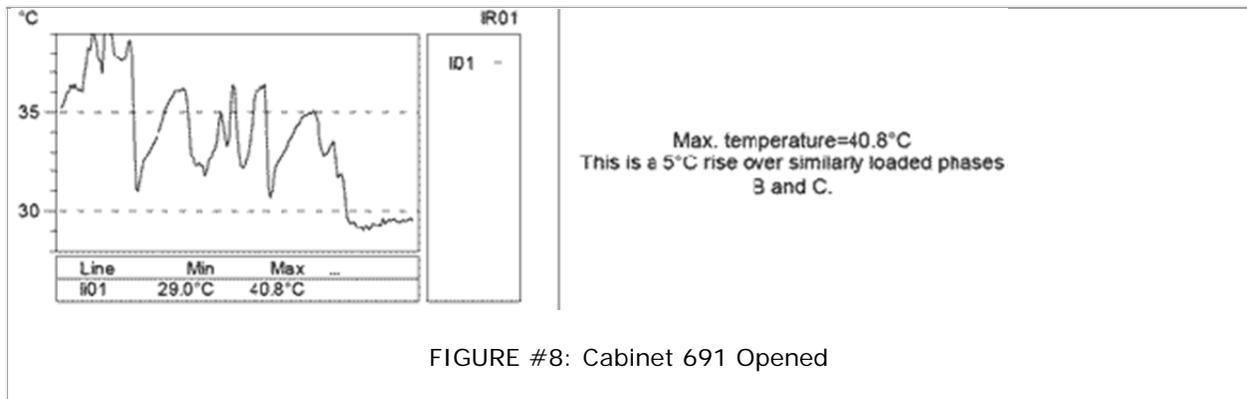
FIGURE #7: Cabinet 692 Opened

The cause of the heat on the warmer 692 cabinet was load related. Cabinet 691 actually had an anomaly that would have gone undetected by not properly removing the cover during the inspection. Also, the fact that this anomaly was found at approximately 10% of the system's rated load shows how a fairly important problem could have been overlooked. Once the load is increased, the heat generated by the fault will increase exponentially. Our calculations would have this rise increase to approximately 110°C when the transformer was under 80% load.

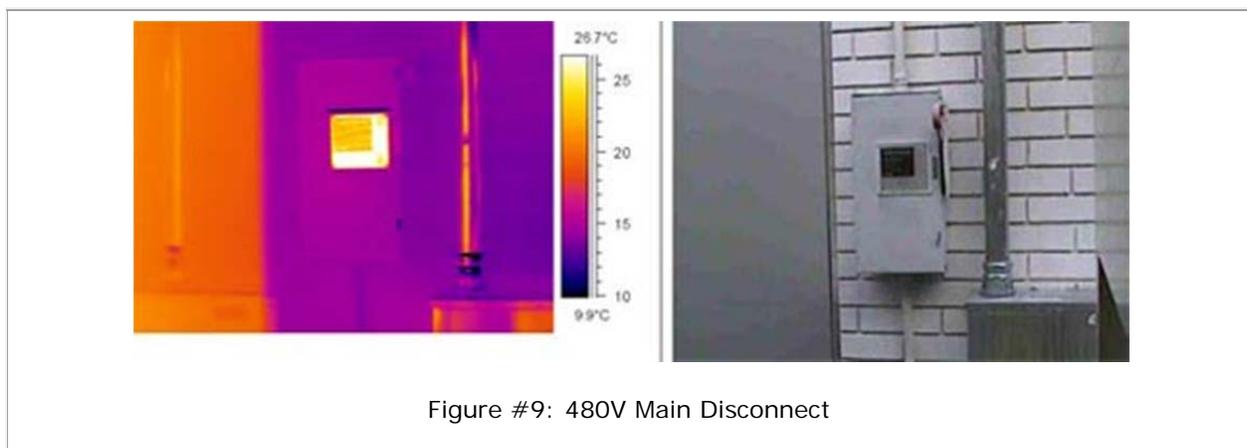
Our next example is of a 480V main disconnect on the outside of a customer's business. As I pointed out earlier in this paper, we took IR images from the outside of the cabinet prior to opening it. Figure #9 shows both the visible and IR images of the cabinet.

No issues were noted from the outside inspection. We then opened the cabinet using approved safety procedures and scanned the internal fused disconnect to look for suspicious hot spots. The problem would have been missed! Refer to Figure #10 for an infrared image clearly showing a problem on the C phase incoming connection. We needed to open this cover in order to identify it. The C-phase fuse was in need of replacement, so the recommended action was to replace all three with new fuses.

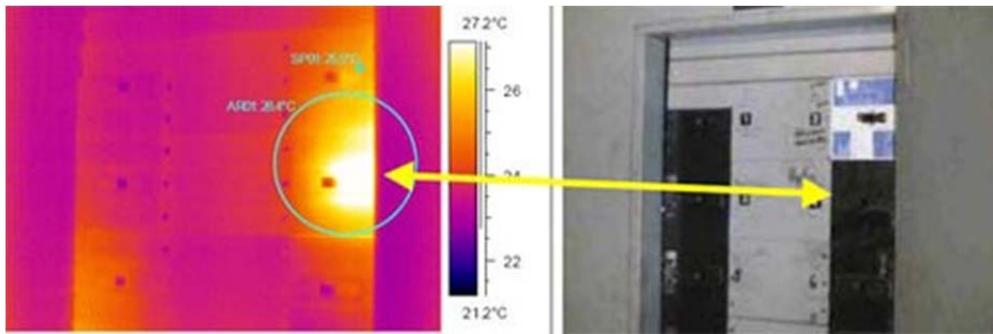
Figure #11: 480V Breaker #4

Our next example in this paper is a medium voltage breaker with the dead front cover still in place. We have a minor temperature rise of about 3°C shown on Breaker #4 (see Figure #11).

This infrared image shows that the breaker is a little warm, but not warm enough to warrant further investigation, right? We pulled the dead front cover, again following all safety regulations, to see if there was anything worth reporting to our important customer.

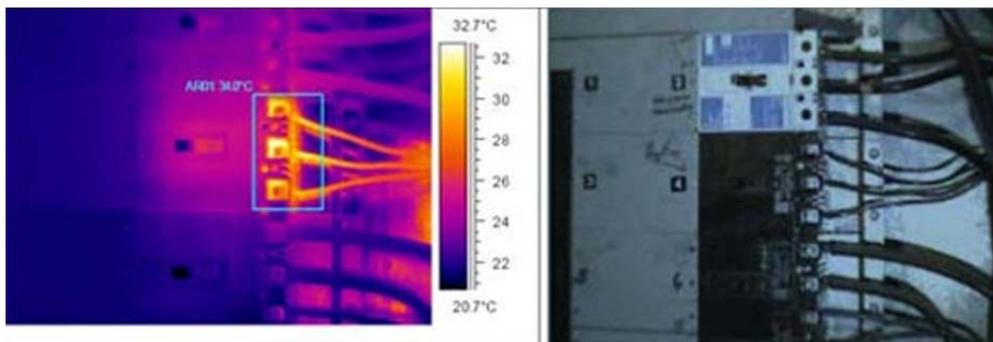
Figure #12: 480V Breaker #4 with Load Side Cover Removed

This image (Figure #12) shows that the contact temperature was about 10°C higher than what was shown on the surface of the breaker. Also, NO anomaly was shown on the outside of the cover itself. We decided to remove the buss side cover to investigate the other side.

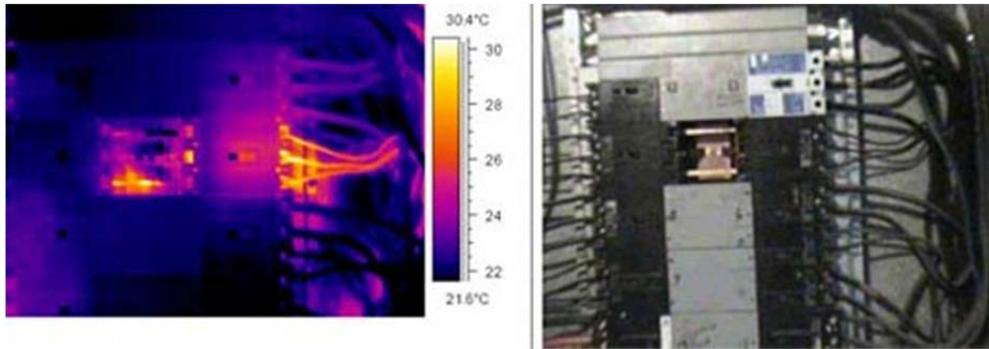
Figure #13: 480V Breaker with Buss and Load Side Cover Removed

With the load side cover removed (Figure #13), we noted a slight rise on the middle phase connection. The “issue” on the bottom phase buss was a reflection, but the connection was a true hot spot. It was at this point that we used our other tools available to get a voltage drop across the different connections and breaker contacts to determine where our issue was emanating from. With over a .275-millivolt drop across the B-phase contact of the breaker itself, we determined that Breaker #4 was in need of replacement.

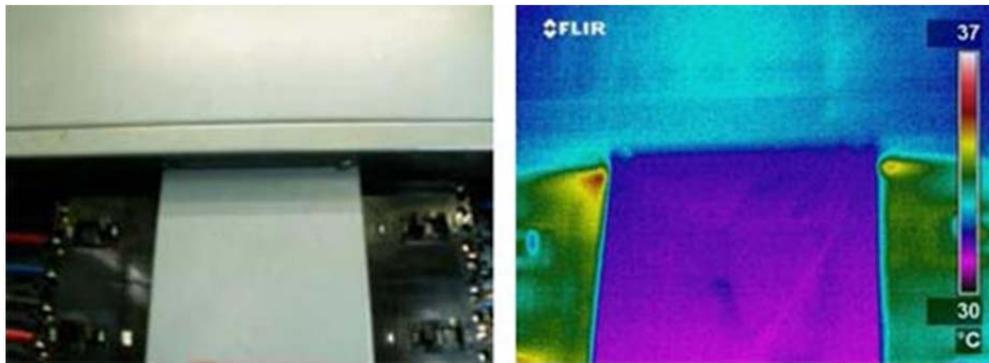
Figure #14

In one final example at a Medical Treatment Center in Fairbanks, Alaska, a Square D I-Line Panel rated at 800 amps was our target. Prior to performing any maintenance on the equipment, the customary Ultrasonic Airborne Safety Scan was performed and no anomalies were detected. As an additive safety precaution, we also conducted a brief IR scan with the camera on the exterior of the panel. The Digital and Infrared images are illustrated below in Figure #14:

As indicated in the images, there are no alarming thermal patterns on either the dead front cover (around 30 degrees C) or the main lug access cover. Some indications at the top corner of the dead front do illustrate some energy, but this could be merely load related heating effects. Once the dead front cover is removed, it is a bit more apparent that there is some type of heating occurring near the top of the panel, which is indicated in Figure #15 below:

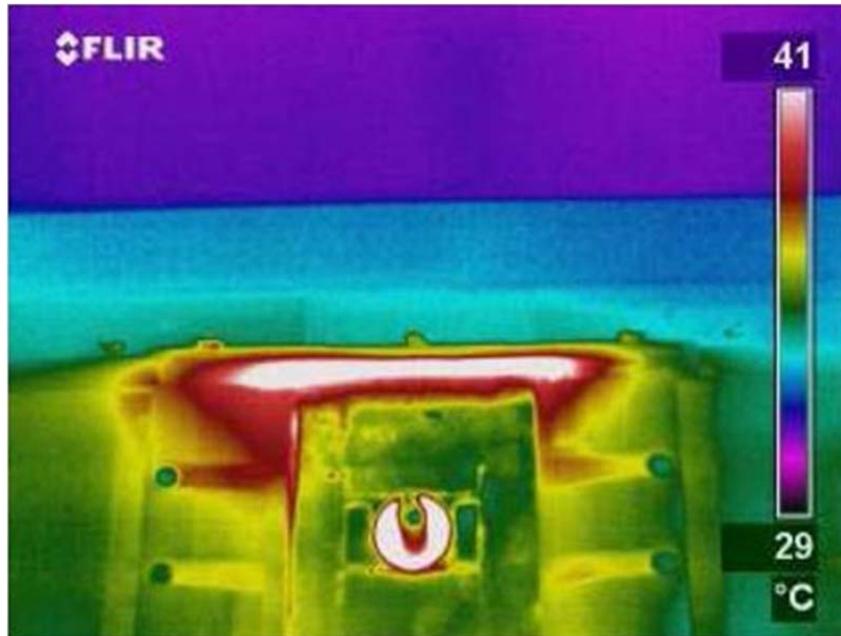
Figure #15

The image above certainly illustrates that there is something suspect within the panel (now the temperature is around 42 degrees C); however, it is still not conclusive as to the source or the severity of the condition contributing to the thermal emission we are observing. Once the top main lug access cover is removed for inspection, it becomes reasonably clear that there is a deficiency on the main lug connections illustrated in Figure #16, but where and which one(s)?

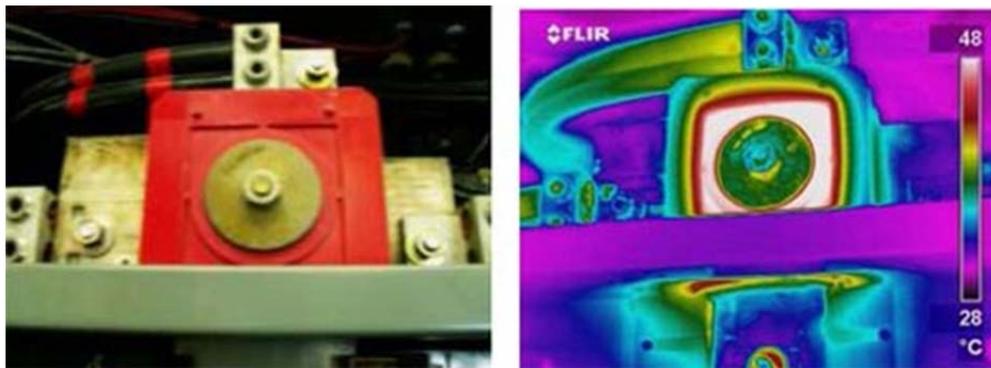
Figure #16

Even without the implementation of complete analysis procedures, it is evident that the problem is centered on the main lug assembly, and that the problem temperature is actually 53 degrees C. This is nearly a 22 degree C error in temperature with the covers on and with them removed. Additionally, terminations are rated at 65 degrees C absolute, and this 800 Amp panel had balanced loads of 450-460 amps. This represents only 50% of its rated capacity, and not all of the customer's loads were in use at the time of the visit. Once these additional loads are added, the problem temperature will then begin to increase exponentially, and it won't be long before it will exceed the 65 degrees C rating of the lugs. This will cause them to rapidly deteriorate and ultimately fail, possibly causing a fire and damage to other components.

Once this evidence was presented to the customer immediately while on site, authorization to perform the repairs was secured for 12:00 AM that evening. The panel was deenergized, the main lugs were disassembled, inspected, cleaned with emery cloth, new hardware was used to reinstall it, the toggle bolt was torqued to Square D's specifications, and the panel was returned to service.

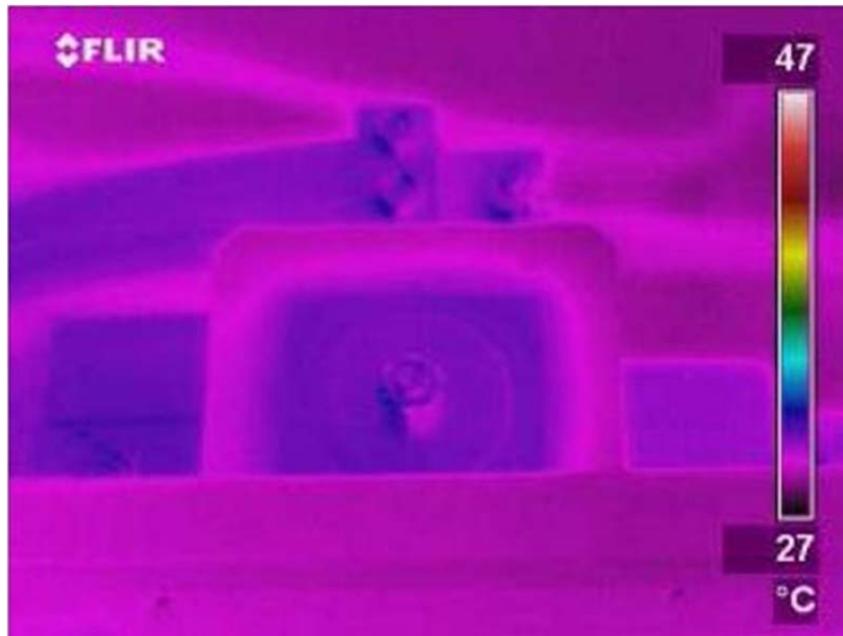
At this point the job is completed, right? Wrong! We must ALWAYS return to verify any repairs we perform, particularly on agreements where they are guaranteed, using the IR camera to provide an illustration of how effective repairs were. In this case, you can see below in Figure #17 that they were extremely successful when returned to service. Under the same operating conditions, the "problem" temperature was reduced by nearly 25 degrees C, and is well within acceptable operating parameters.
